Technical Bulletin

Issue No. 17

CONDENSATE REQUIREMENTS

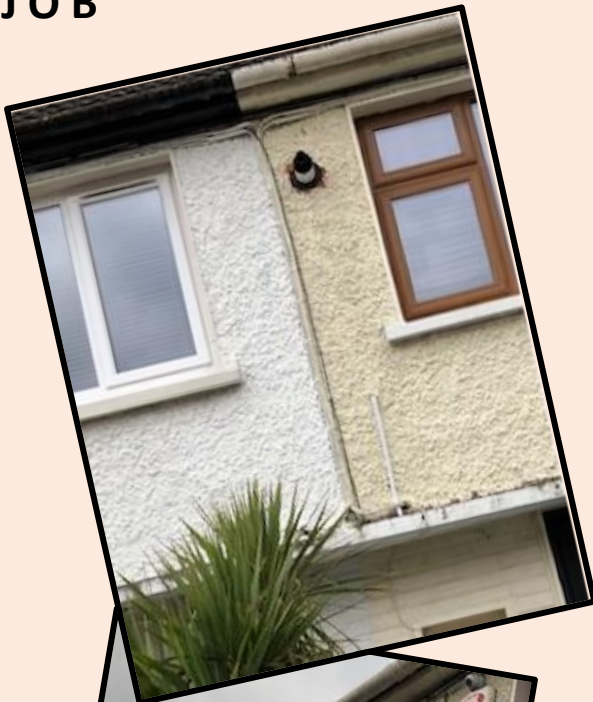
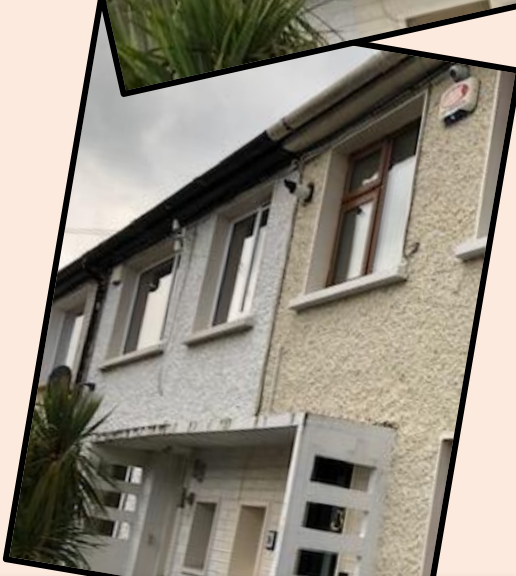
An RGI when carrying out an Annual Service found that the Condense Pipe from the High Efficiency Boiler was terminating directly onto the roof of a porch.

Two years previously the original installer had replaced a Standard Efficiency boiler which would not have had a condense pipe system.

Rectification of this matter entailed moving the boiler to the back of this house with access to the wastewater drainage system.

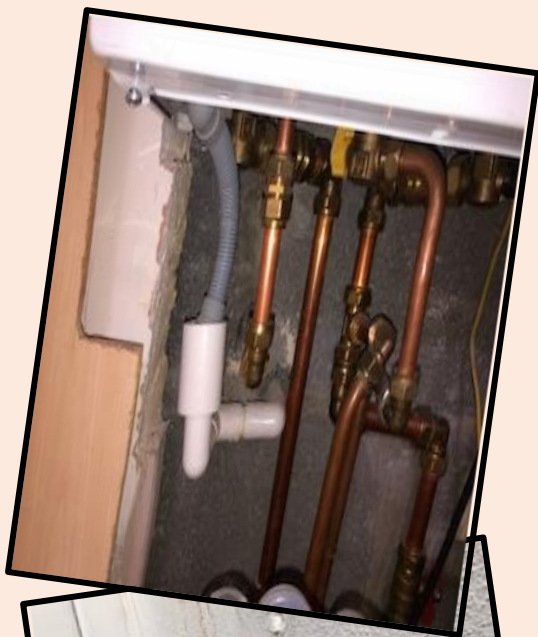
An RGI identified this problem whilst carrying out a Service Repair job.

The internal condensate pipe had a steep incline rather than a minimum 2.5 degree fall and contained unnecessary 90-degree bends.

Another concern was that the external condensate pipe was terminating onto a pathway creating a serious hazard.

Rectification of this problem involved the refitting of the complete condensate pipe system. The pipe size was increased to 30mm through the wall to outside and piped into an external household drain.

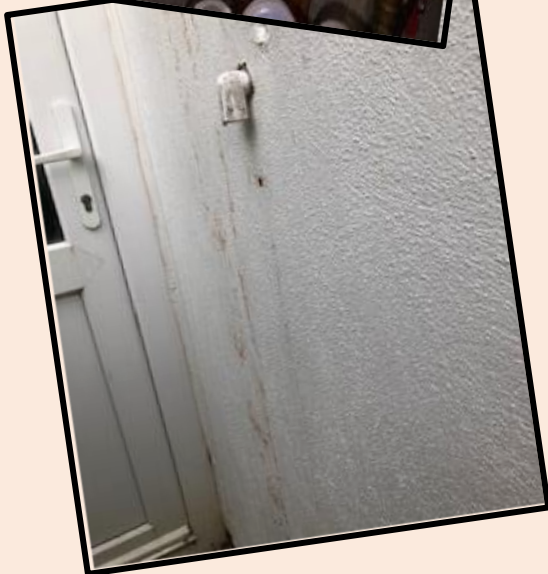
This particular issue was identified by both the RGI and his Inspector during the course of an Annual Inspection.

As the section of condensate through the wall is 22mm with a 90-degree bend, the condensate was susceptible to freezing when temperatures dropped below freezing despite the installer increasing the pipe size externally.

The RGI proceeded to rectify the issue by replacing the 22mm section with 32mm pipe. This was an unforeseen additional cost for the customer.

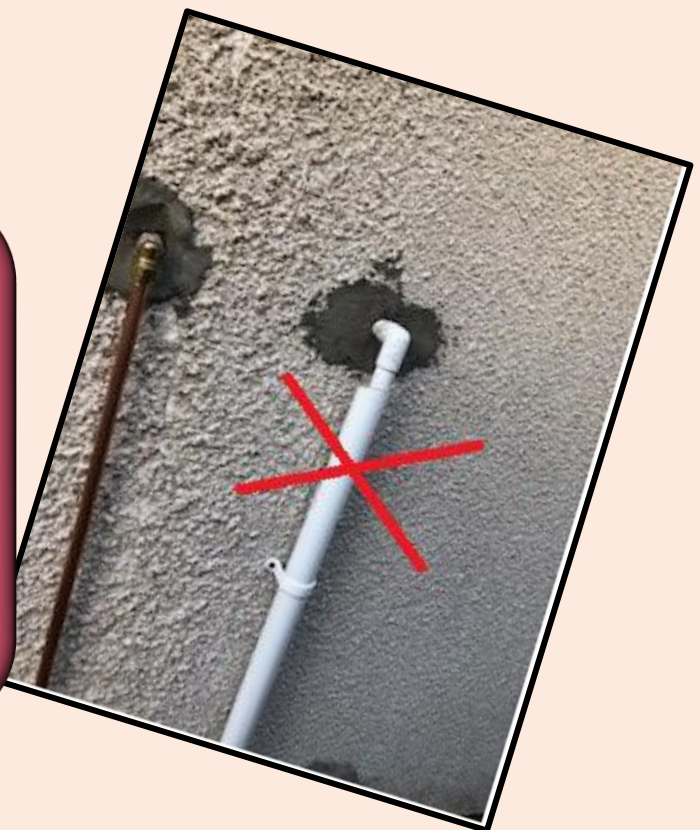
This was a particularly poor condense pipe installation. The original Installer had failed to pipe the condense discharge directly into the wastewater drain, creating a slip hazard and causing staining damage to the paving stones. The RGI carrying out the service work carried out the necessary remedial works.

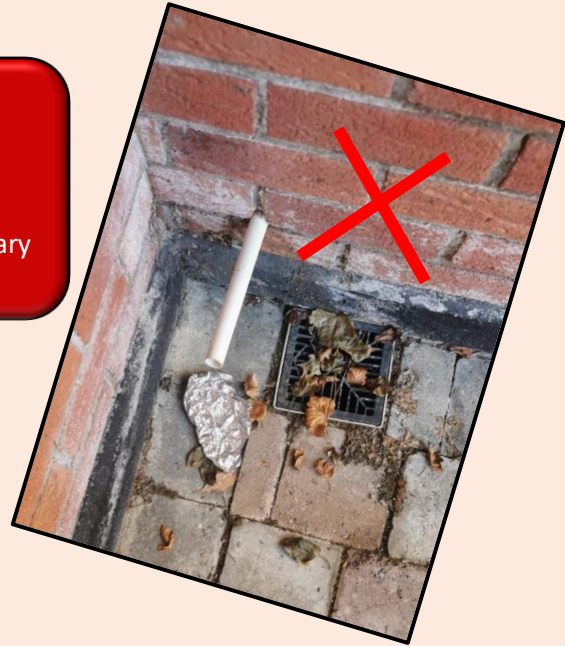
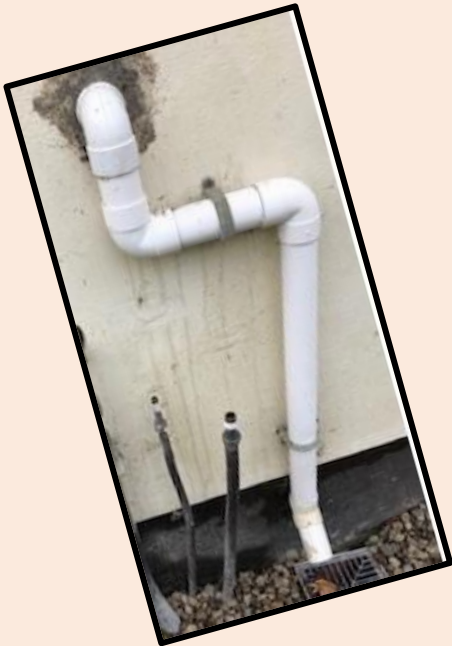
Here is an example of where an RGI had taken the necessary steps to increase the size of the condense pipework to 32mm. However, he utilised three 90° bends externally where one 90° bend with an offset or a 45° bend would have sufficed on the downpipe section would have sufficed.

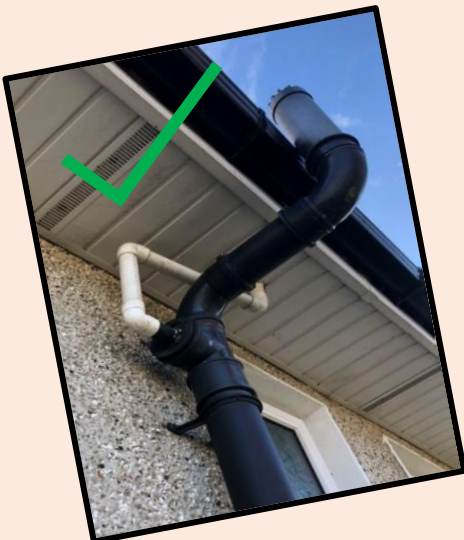
Retrofit installation where the boiler was relocated into the attic. The RGI piped the condense into the vertical soil pipe using an approved soil stack pipe branch. The condense pipe was increased in size and branched into the soil pipe at a high point to eliminate the possibility of freezing.

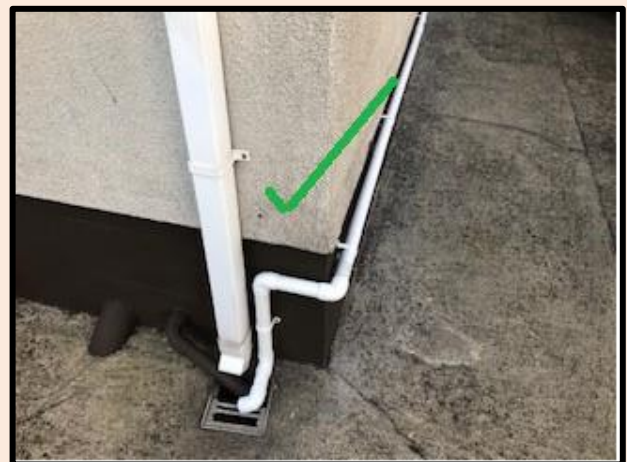
For this arrangement, the HE Boiler was located in a converted garage a distance away from the nearest external drainage system. The RGI took the necessary measures to ensure that the condense pipe size was increased from 22mm to 32mm, there was sufficient fall on the horizontal pipe runs, the pipework was adequately bracketed, and it was correctly terminated into the wastewater drainage system.
