Safety Notice

Issue No. 22

LEAN-TO AND ROOF COVERINGS

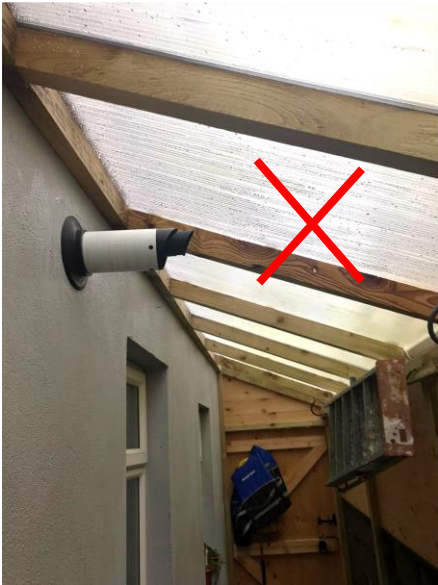
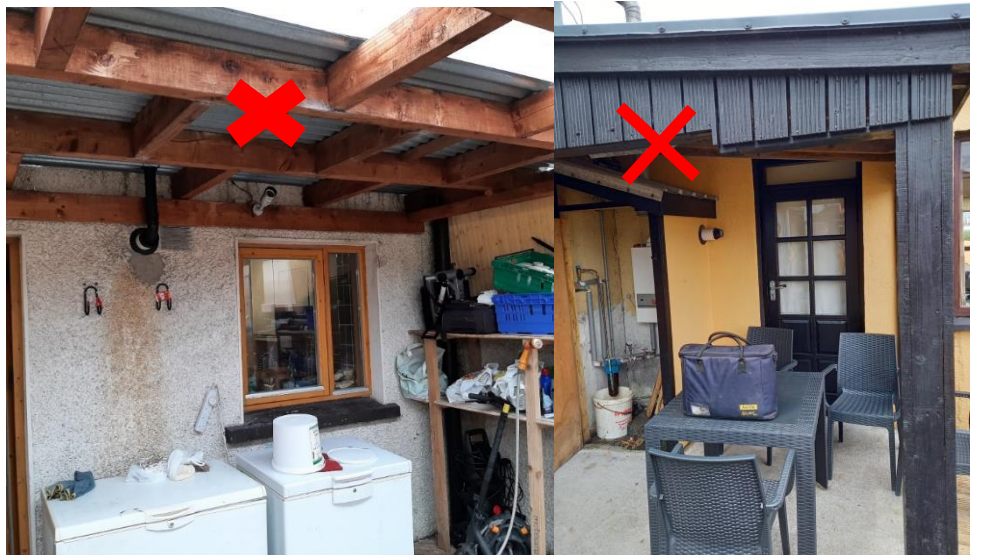
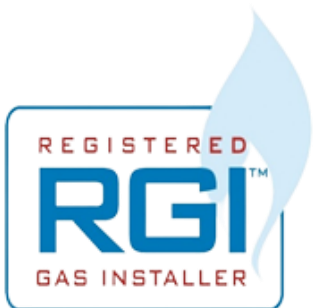
A number of these structures are now restricting and/or preventing the safe discharge of flue gases into the atmosphere, restricting the air movement around the flue, and increasing the probability of recirculation of the products of combustion.

Prior to the installation of these roof structures, the flue installation was compliant with the relevant standards and installed in accordance with the boiler manufacturer's instructions.

In addition to the gas appliance isolation steps covered under **I.S.813 Section E.9**, RGI's should provide safety advice options to the customer, landlord or tenant as follows:

1. **Remove the offending roof construction**
2. **Relocate the gas appliance**
3. **Extend the full concentric flue (if practicable) in accordance with manufacturer's instructions.**
