# Technical Bulletin

**Gazco Riva2 800 & 1050 Gas Fires- Installation and servicing issues resulting in Glass Panel Failure**

**October 2015**

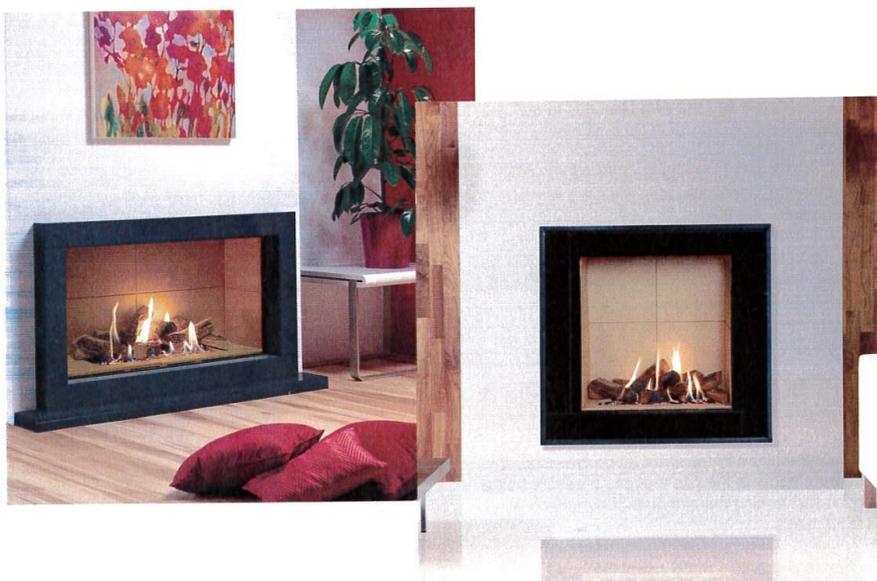
Product Safety Inspection Instructions for appliance owners and users

1. Ensure all the screws on the glass window frame are present and fitted correctly.
2. Observe the ignition sequence to ensure the appliance lights correctly.
3. Check the Pilot Unit to determine that the Pilot flames are not reduced or obstructed and the pilot burner is in the correct orientation.

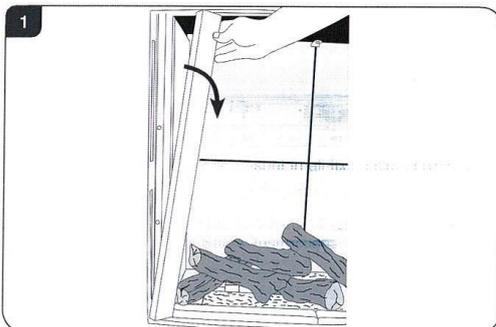
- 1.1 The side trims are decorative metal strips that are held in place by magnets.

To remove the side trims, lever the top out of the channel and pull down to release, see Diagram 1.

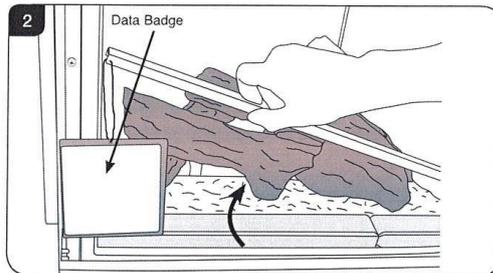
- 1.2 Lift out the slotted trim from the bottom of the appliance in the same manner, see Diagram 2.

The appliance Data Badge is attached to the bottom trim so take care when removing to avoid scratching the finish.

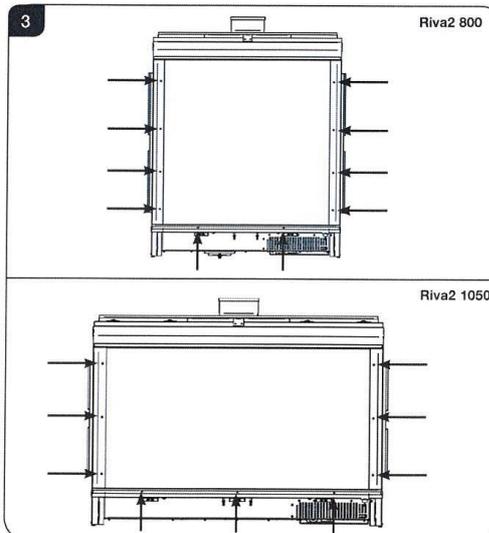
- 1.3 With the decorative trims removed it is possible to view the glass window frame, which is held in place by screws.

Riva2 800 models have 10 screws.  
Riva2 1050 models have 9 screws.  
See Diagram 3 for location.

- 1.4 Ensure that a screw is present in all fixing slots (10 in the Riva2 800 and 9 on the Riva2 1050).

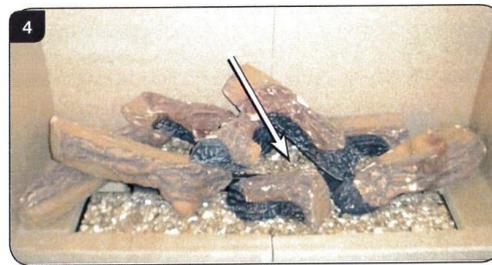
- 3.1 With the appliance in Pilot Only mode check the length and thickness of the Pilot Flame.

The Pilot Burner is located behind the front log of the fire bed and is perfectly visible when up close to the appliance viewing panel, see Diagram 4.

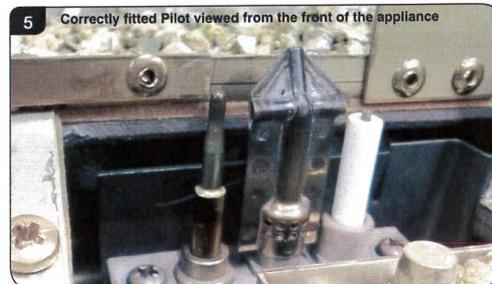
- 3.2 Without logs on the fuelbed a Pilot Unit fitted in the correct orientation faces away from the front of the appliance, see Diagram 5.

We DO NOT recommend end users remove the logs but this can be checked during a service by an appropriately qualified GasSafe engineer.

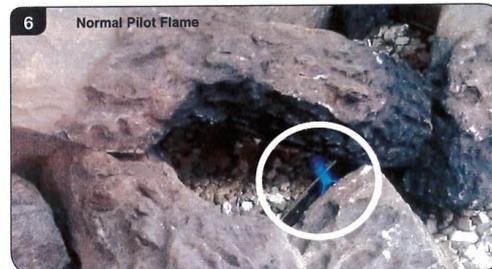
- 3.3 A normal Pilot Flame should be a tall and thin, blue flame with occasional yellow tips see Diagram 6.

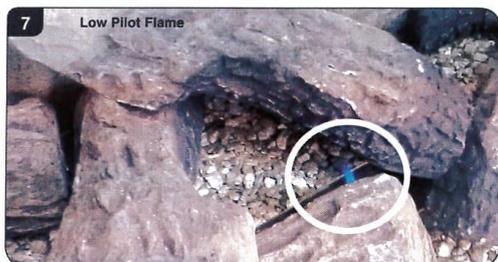
3.4 A reduced Pilot Flame will be short and fat, see Diagram 7.

3.6 If the Pilot Flame shows signs of obstruction or is in the incorrect orientation switch off the appliance immediately by pressing the OFF button on the remote control and contact Gazco before attempting to relight.

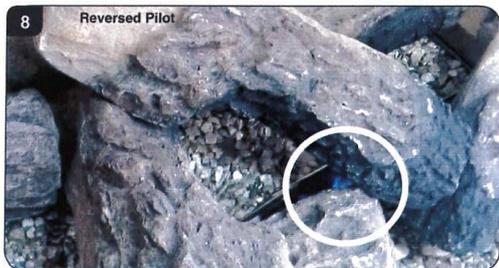
3.5 A Pilot that has been fitted in the reverse position will hardly be visible and have a flame that points forward, being obscured by the front log, see Diagram 8.
