# Safety Alert 013

## Title: Potterton Powermax HE - Flue/Condensate Connector Erosion

Date issued: 15 November 2013

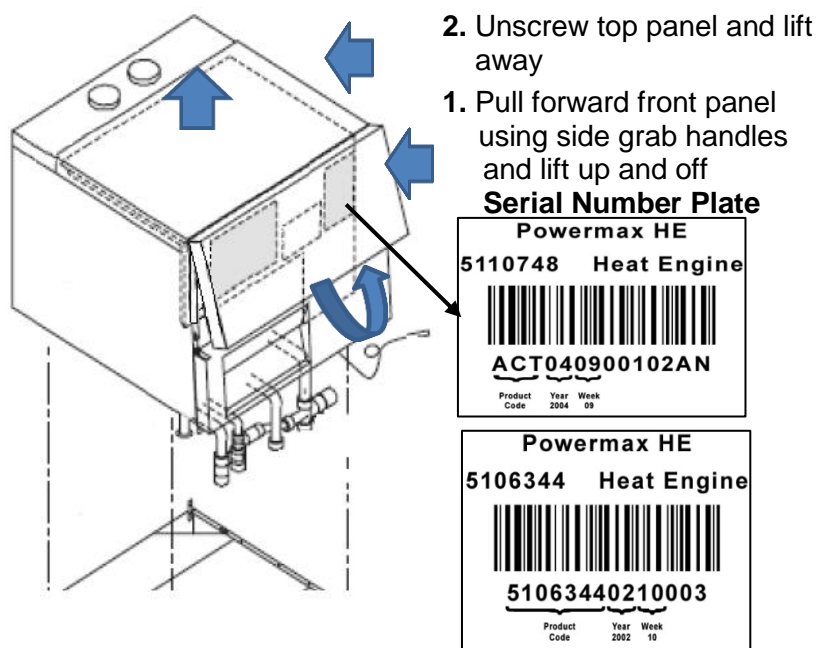
**Figure 1. General Access**

When attending a Powermax HE boiler first check to see if the serial number is in the identified range as listed in Table 1 (below). The serial number is on the data plate which is located as shown below (Fig 1) and contains two examples showing details of the year and week (YY WW) of production.

- 1) The flue/condensate connector is located behind the heat engine at the rear of the appliance. Refer to Figure 1 for access.
- 2) The top of the flue/condensate connector can be viewed from the front of the boiler with the front and top panels removed as shown in Figures 2 & 3. If the boiler has already been fitted with a new flue gas/condensate connector this will be black composite plastic (Figure 4) rather than aluminium (Figure 2).

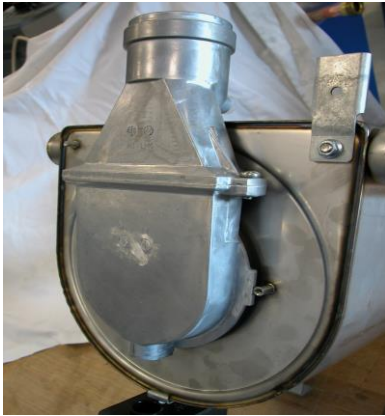
The problem identified centres around the aluminium material that was used to form the integral flue/condensate connector on the earlier production models. Through continuous field monitoring, it came to the attention of Baxi Heating Ltd., that this material is subject to erosion and the rate of erosion is dependant on usage patterns and local site installation conditions.

**Figure 2**  
Aluminium flue/condensate connector attached to the rear of the heat exchanger (Photograph shows the view from the rear of the boiler)

- 4) **If the component is aluminium** carry out a combustion analysis check by referring to the Installation & Service instructions for guidance. If the customer does not have the instruction booklet to hand, it can be found at: <http://www.partsarena.com/baxi>. A combustion test point is provided on the flue/condensate connector. Typical values to be expected are: **At maximum input:** CO < 80ppm & CO<sub>2</sub> < 9.5%. **At minimum input:** CO < 20ppm & CO<sub>2</sub> < 8.9%

- 5) If the levels measured are above these, the cause should be investigated and may indicate a defective component, lack of maintenance, maladjusted gas valve or flue issue. The appliance should be classified as 'Immediately Dangerous' until the cause of the incorrect combustion can be identified and corrected, in accordance with the Gas Industry Unsafe Situation Procedure GSIUR(3).(See Gas Safe Register [Technical Bulletin \(TB\) 001](#)).

Baxi Heating Ltd., **recommends** that all the aluminium components of this type are exchanged irrespective of their current condition.

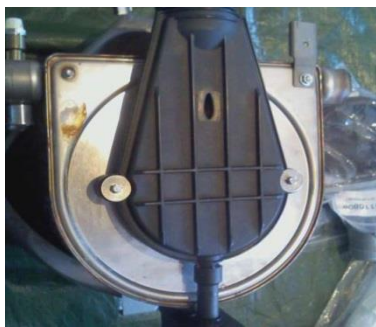
**Figure 4**  
Black composite plastic flue/condensate connector attached to the rear of the heat exchanger (Photograph shows the view from the rear of the boiler)

- 3) If the component is the black composite plastic type **no further action** is required under this Safety Alert, **however** all appliance checks in accordance with GSIUR 26(9)<sup>(2)</sup> must be completed and any subsequent actions applied as appropriate.
