Register of Gas Installers of Ireland
Unit 9, KCR Industrial Estate,
Ravensdale Park, Kimmage,
Dublin 1
T. 01 4997998
F. 01 4929983
Email: installationstandards@rgji.ie

Technical Bulletin

Recalled, Special Interest and Reportable Appliances (revised & re-issued)

September 2014

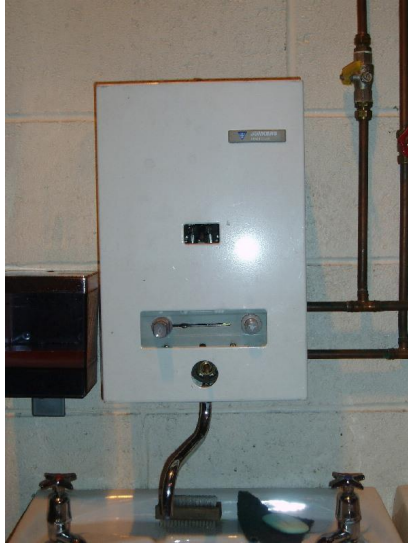
1. Flueless Over Sink Water Heaters without A.S.D. (pre 1996)

Flueless appliances discharge all the products of combustion into the room in which they are fitted. A Carbon Monoxide risk occurs where the appliance is left on for an extended period and/or the room has reduced ventilation. In these circumstances the absence of a correctly operating Atmospheric Sensing Device (ASD) can result in the occupants being exposed to Carbon Monoxide.

1. **ISOLATE** the appliance for safety. Issue a Notice of Hazard to the owner / occupier of the premise and return a copy of the notice immediately to RGII at the address above.
2. **ADVISE: Most Important:** In all cases advise Bord Gáis Networks immediately giving full details of the appliance isolated and location. Ring 1850 200 694.
3. **ASSESS:** If due to the vulnerable nature of the customer the isolation of the appliance would result in undue hardship for the customer contact BGN for assistance.

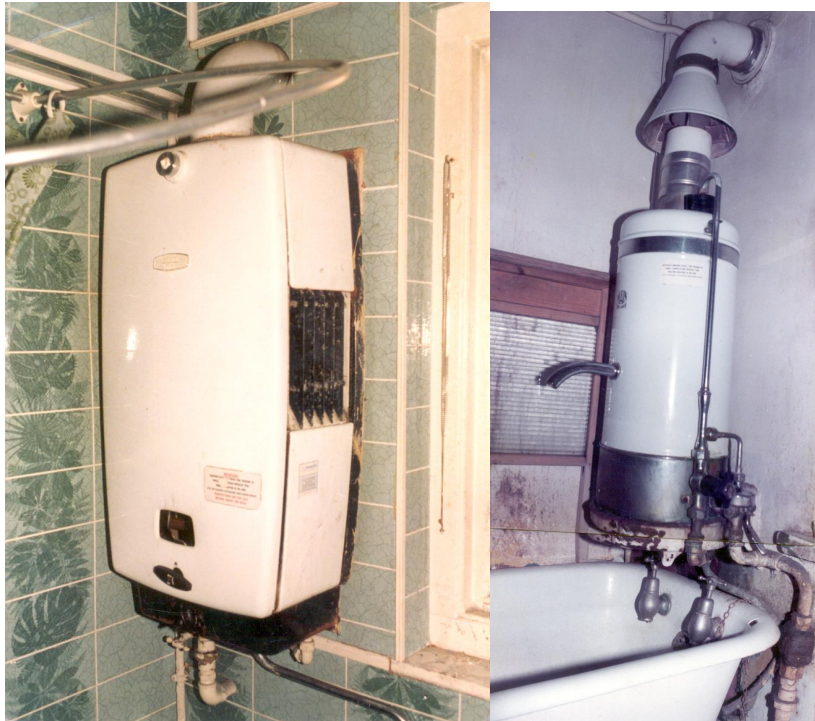
2. Open Flued Water Heaters in Bathrooms

Incidents can occur even in circumstances where the appliance was installed in accordance with the installation standards in place at the time of installation.

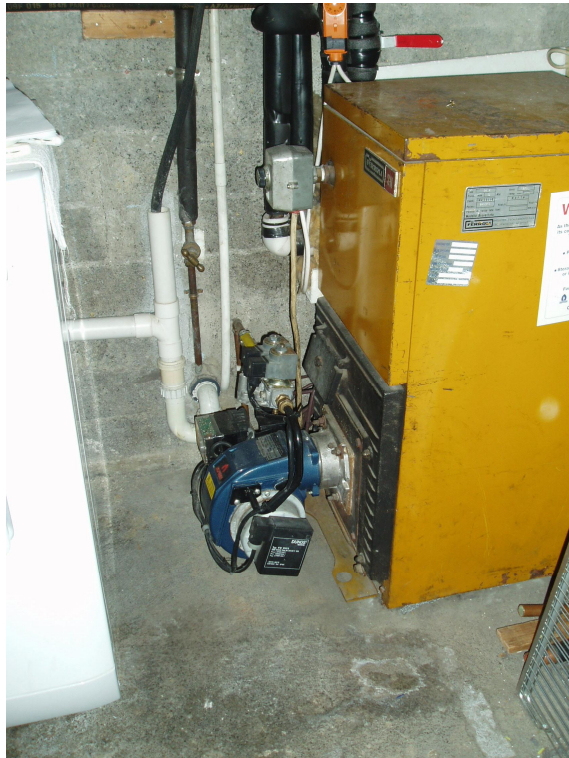
Open Flued Oil Burner Changeover's (Forced Draft)

An Open Flued Boiler originally burning oil that which was converted with a forced draught gas burner for use with Natural Gas i.e. a burner to burner changeover

1. Identify the appliance and check:
 - Suitability of location
 - Ventilation

- Flue condition and effectiveness

Carry out a flue flow test, a spillage test and a flue gas analyses

Ensure flue is free of corrosion complete throughout its length and all visible joints are sealed and in good condition. Inspect joints and seals at both the boiler and flue/chimney.

2. If the unit is not safely installed **ISOLATE** the appliance. Issue a Notice of Hazard to the owner / occupier and return a copy of the notice immediately to RGII at the address above.
3. If the unit is safely and properly installed advise the user on the safe operation, the need to ensure vents and flues do not become blocked and the **need for annual servicing of the appliance.**
4. Consideration should be given to the fitting of audible CO Alarms at the premise.
5. For replacement of these gas appliances a **room sealed** unit should always be offered as the first choice for safety.

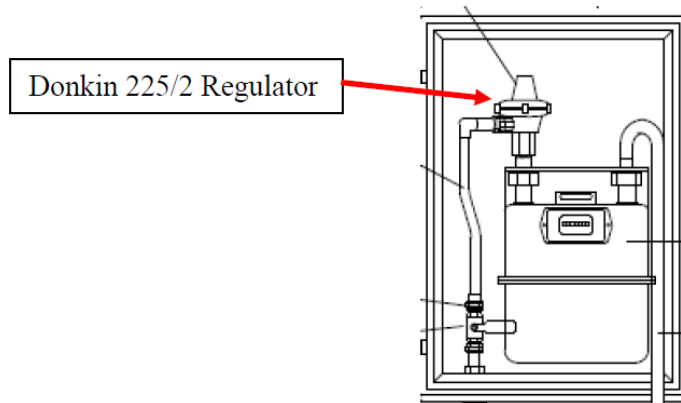
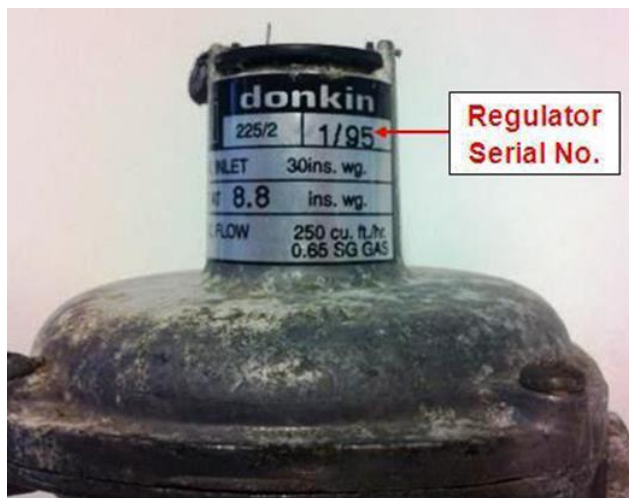
4. Donkin 225 Regulator

Manufactured and installed on low pressure domestic services up to 1997. Can be located either with or without a meter box. An issue has been identified which requires their removal

If you discover one of these regulators during your work please contact BGN on

- House /Address Details
- GPRN
- Meter Number
- Donkin 225/2 serial number (See regulator above).

If you discover a Donkin 255/2 regulator that is leaking gas you must turn off the MCV (Main Control Valve) and call the BGN emergency line on

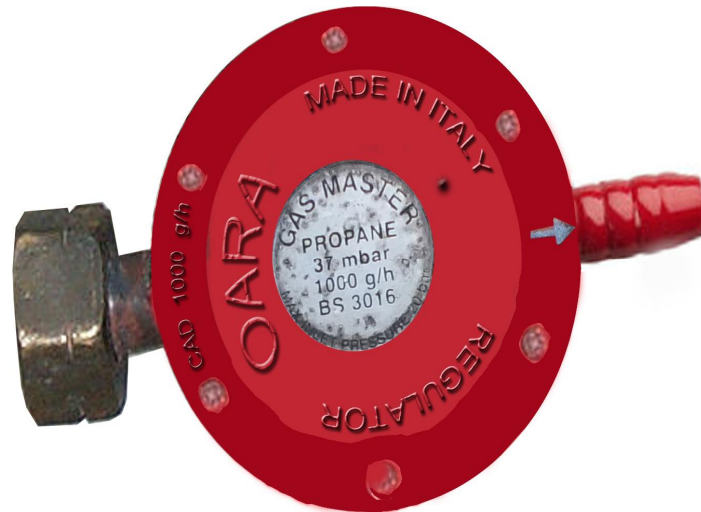
5. LPG OARA Gas Master Range Regulator

This model regulator has been found to be prone to failure caused by internal corrosion, resulting in an over pressure condition and should therefore be replaced and removed from service

Regulators should be maintained or replaced as specified in the manufacturer instructions, or in the absent of any manufacturer instructions, after 10 years in service.

Regulators designed for outdoor use should be kept at least 500 mm above ground level, to avoid the vent opening becoming blocked. It is very important that regulators are always positioned with vent opening facing in the downwards direction, to avoid ingress and accumulation of water inside the body of the regulator

The Irish LP Gas Association (ILPGA) recommend that existing installations fitted with a single stage regulator without protection, be upgraded and fitted with a regulator with over pressure or excess flow protection, as recommended in Irish Standard I.S. 813:2014 Domestic Gas Installations
