Technical Bulletin

Issue No. 17

CONDENSATE REQUIREMENTS

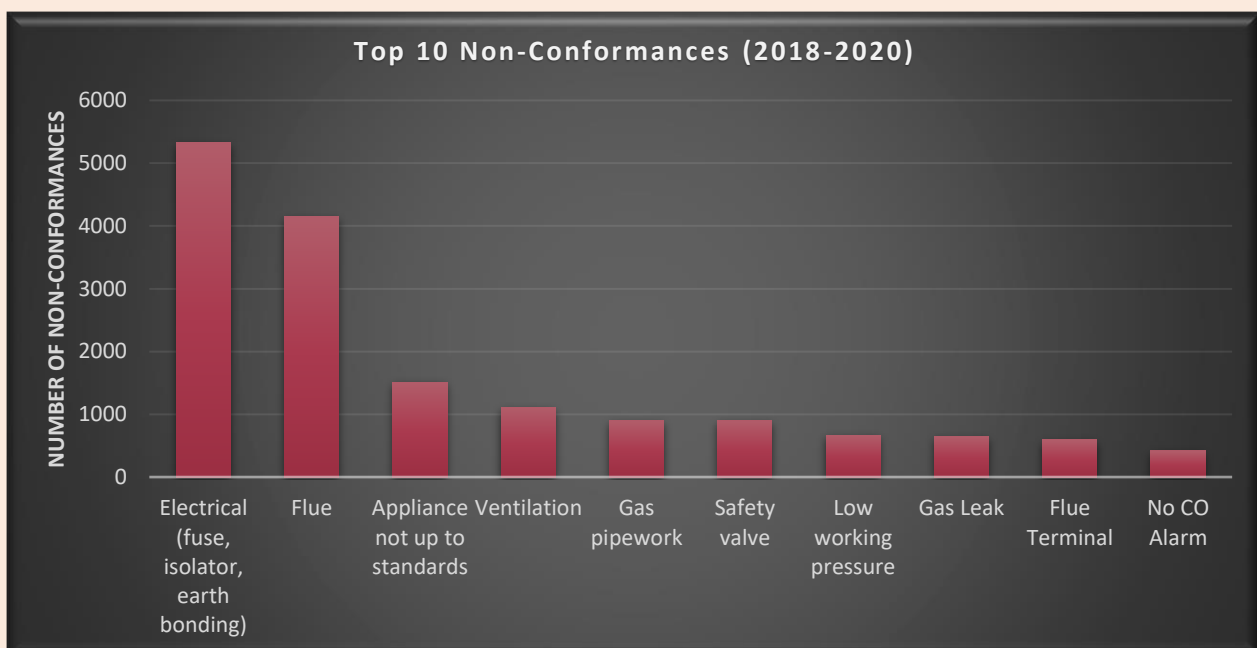
Below is a chart showing the Top 10 non-conformances found by both RGIs and RGII Inspectors in the period between 2018 and 2020.
