Safety Alert 020

Title: Viessmann Vitodens 100-W system boiler

Date issued: 7 December 2016

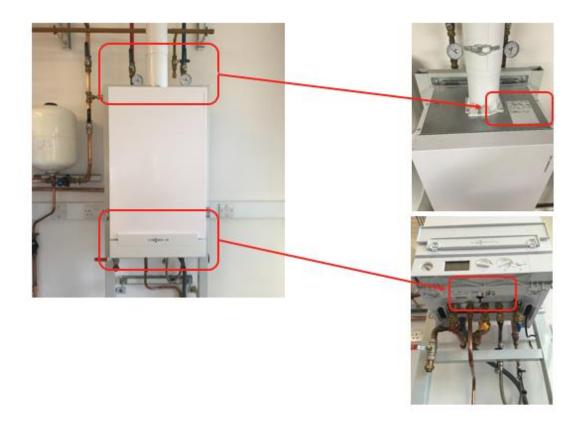
Gas Safe Register[®] has used its best efforts in the production of this information, but makes no warranty about the content and will not be held liable under any circumstances for any direct or indirect damages resulting from the use of this information. This document may not be reproduced in whole or in part without the consent of Gas Safe Register[®] other than for personal reference purposes only. This document is uncontrolled when printed, please visit: <u>https://www.gassaferegister.co.uk/sign-in/</u>, login and visit the Technical Information area for the controlled (current) copy. © Capita Gas Registration and Ancillary Services Ltd, 2011. Serial number can be found in one of the two following locations on the boiler case:
